WHITE PAPER

Fluorescent Lamps and Striation

Stan Zajac

Advance
10275 W. Higgins Road
Rosemont, IL 60018

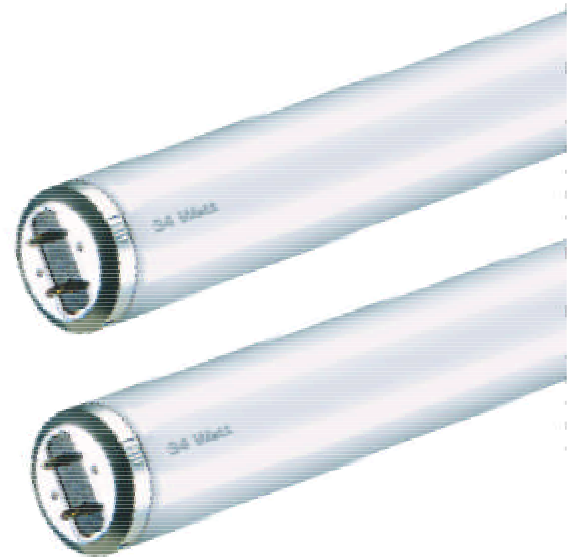
- b) Ambient Temperature - Fluorescent lamp output is directly proportional to its bulb wall temperature. Every lamp has its optimum temperature for maximum light output. If extreme cold ambient temperatures exist, the light levels will be visually less and lamp striations may occur. It may be possible to reduce or eliminate this condition by using lamp tube guards or utilizing a luminaire that retains more heat in the lamp compartment. Please contact the lamp manufacturer for information regarding the use of tube guards with their lamps.
